Inspection Report

American Property Inspections

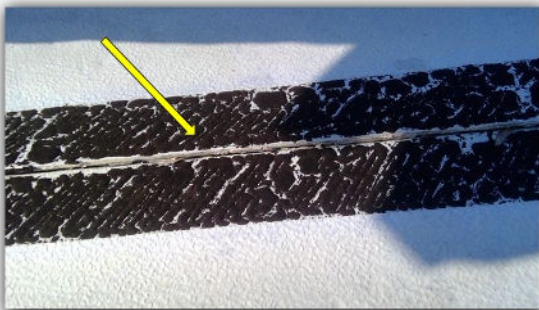
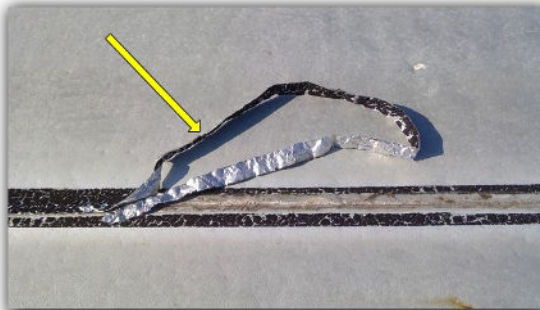
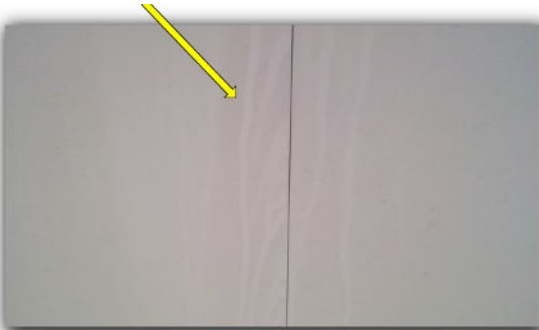
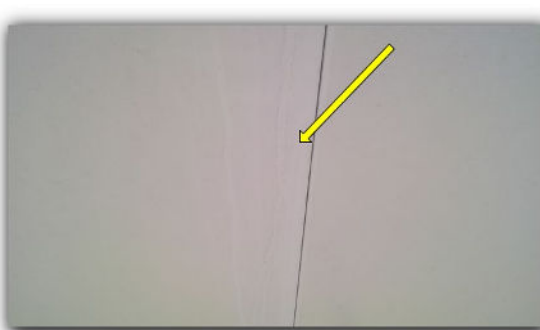
Seams have deteriorated/damaged at rear metal roof over porch. This will allow water intrusions, water marks are visible at rear porch ceiling . Requires repair by a licensed roofer.

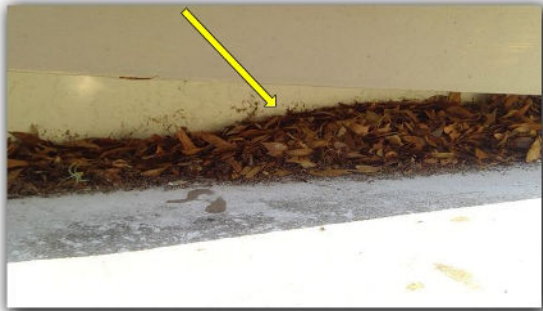
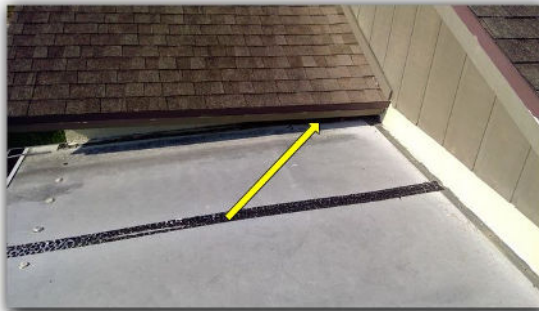
Debris and tree branches on roof at rear right. Requires removal.

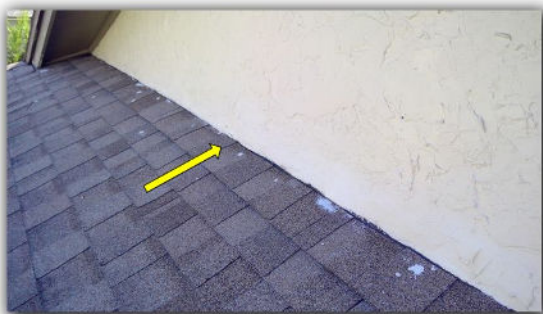
Gap is not present between roof and lower portion of wall at front. There should be gap of at least 1 1/2 inches between the bottom of the exterior wall covering material and the top of the roof covering material to prevent water intrusion and/or decay of wall material.

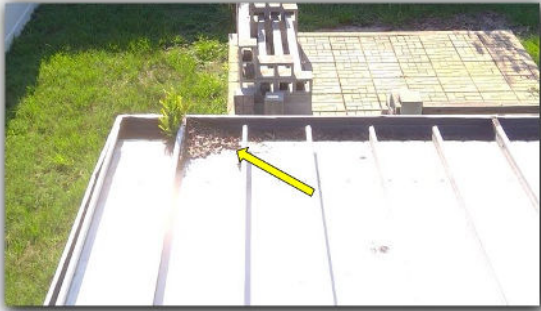
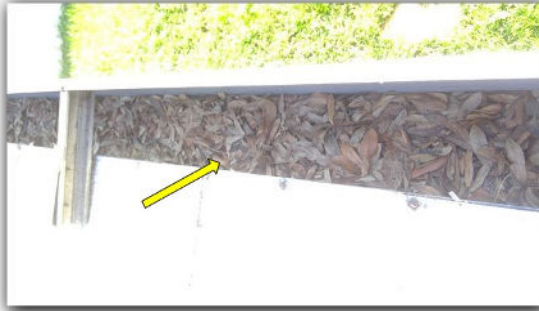
Gutters are full of debris at rear. Requires cleaning of gutters to ensure proper drainage.

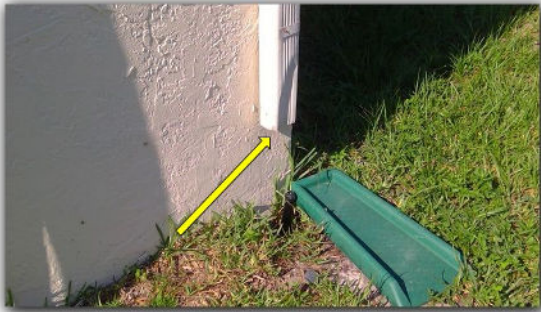
Downspout return is missing or damaged located at front left corner. Requires repair or replacement.

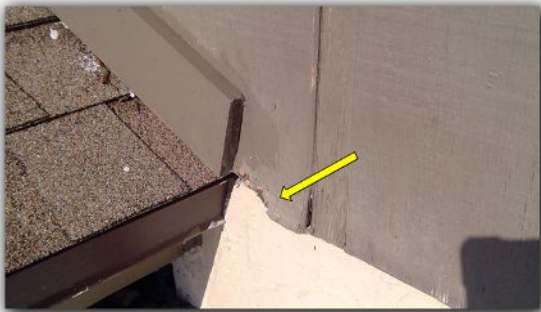
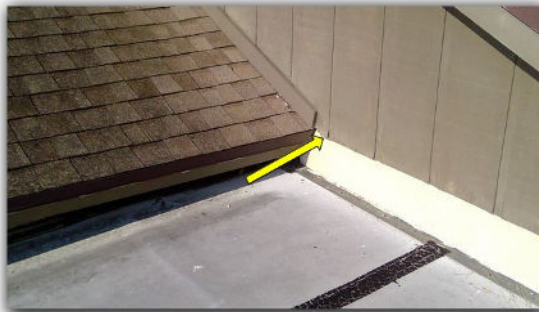
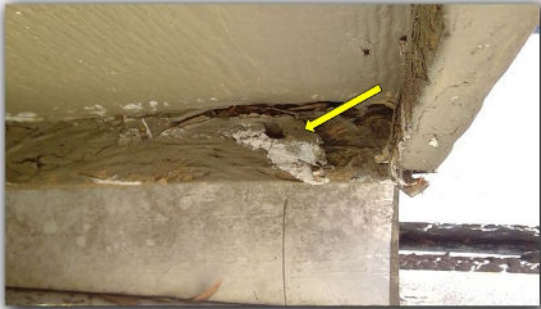
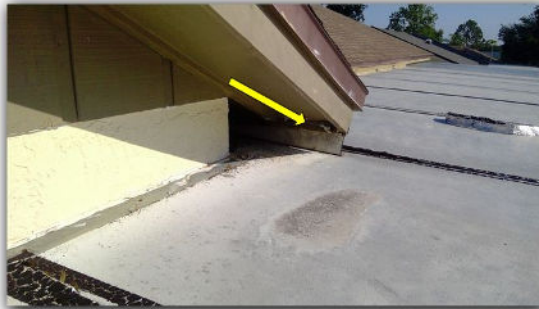
Wood decay is present on siding and fascia at rear right. Wood decay is a species of fungus that digests moist wood, causing it to rot. All decayed wood requires replacement with new wood. Water and moisture damage may be present in walls or structures that are not visible to the inspector without further intrusional inspections.

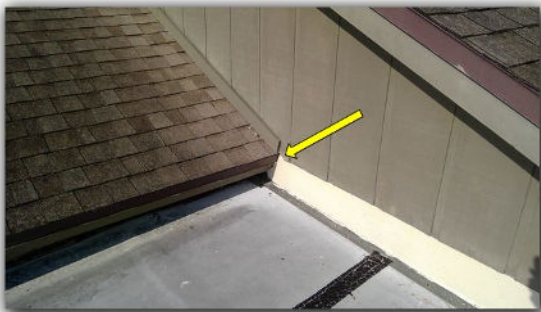
Kick out flashing is not present at rear right. Kick outs redirect water away from flashing's, stucco and siding eliminating possible water intrusion or wear of the stucco or siding. Recommend they be installed in this location.

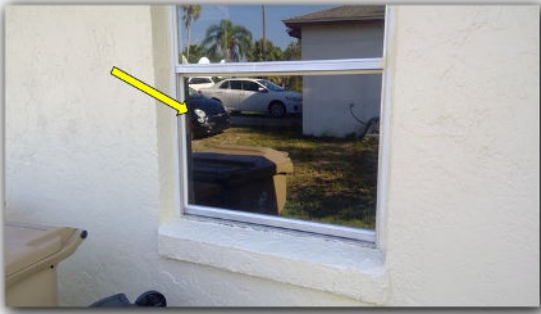
Window does not have screen present at right. Requires installation of screen to prevent insect intrusions.

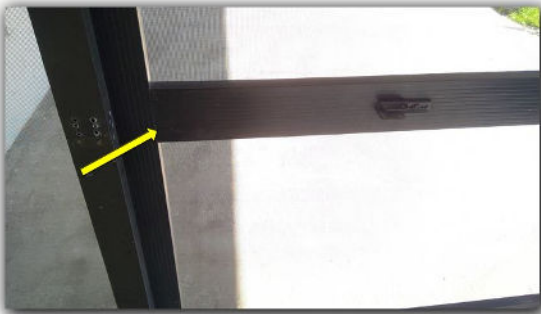
Door closer is missing at rear porch door. Recommend installation.

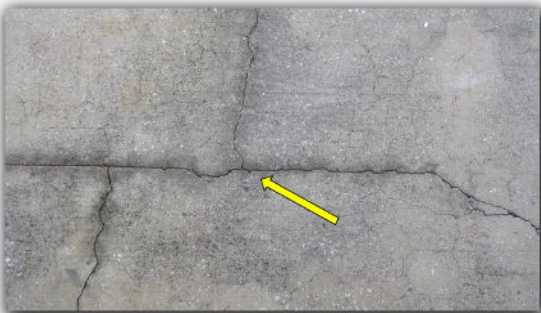
Settling cracks are present in driveway. These cracks are not considered structural. Sealing cracks may be a viable option to preventing any type of possible water intrusions.

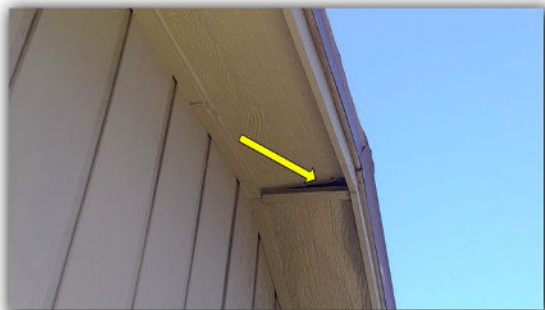
Gap is present at left side eave. This may allow rodent and insect intrusions. Recommend sealing areas.

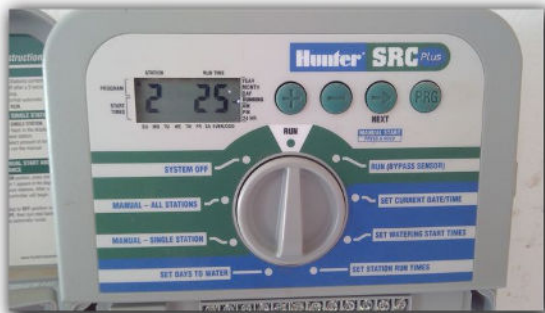
Irrigation did not respond to controller. Requires further investigation and/or repair by a licensed irrigation contractor.

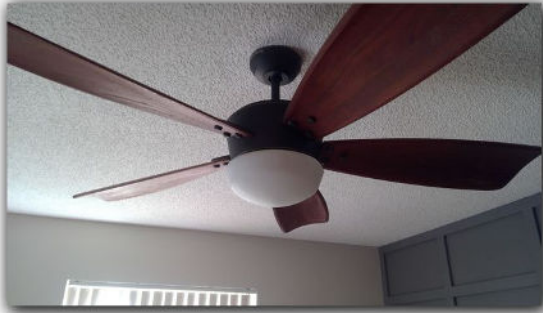
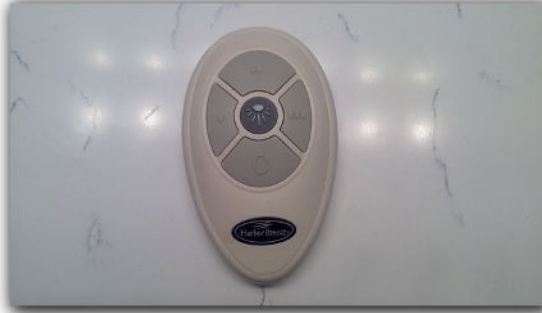
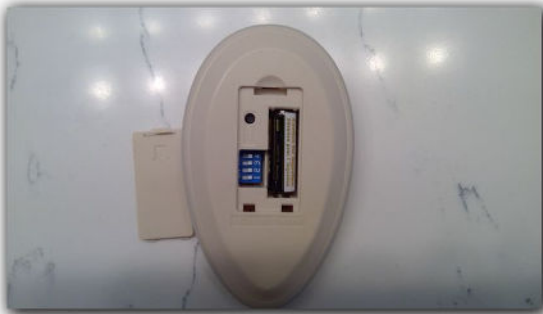
Fan/light did not operate using remote control in primary bedroom. Possible dead battery at remote. Recommend further evaluation by a licensed electrician.

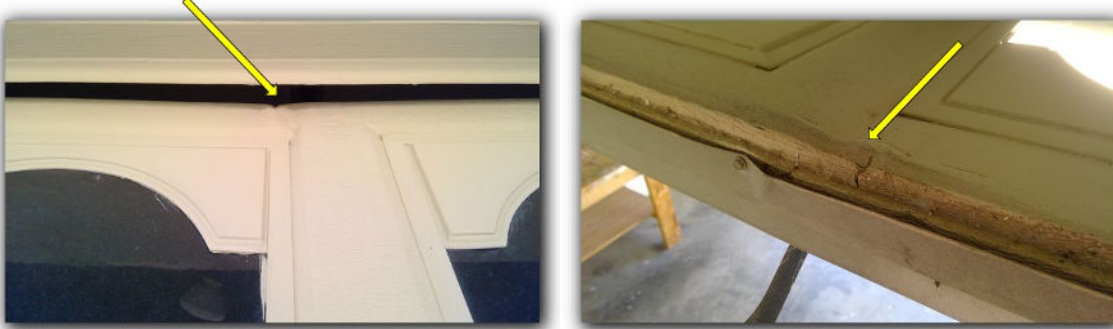
Overhead door is damaged at top middle. Requires repair/replacement.

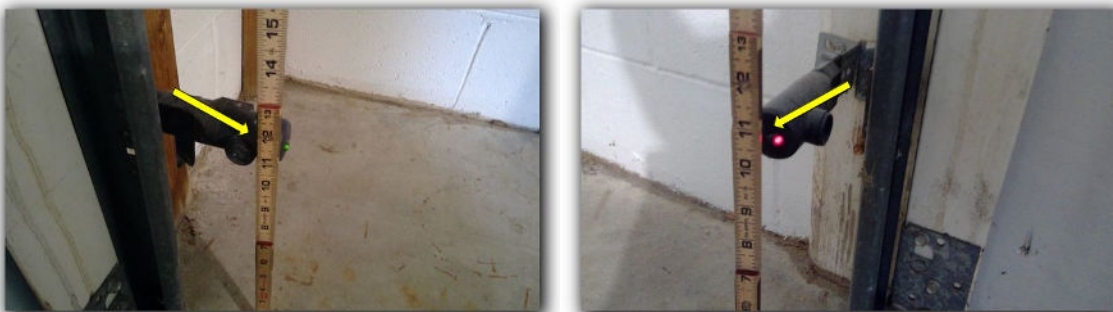
Door sensors are not mounted at a proper height. Door sensors should be relocated between 4-6" from floor level.

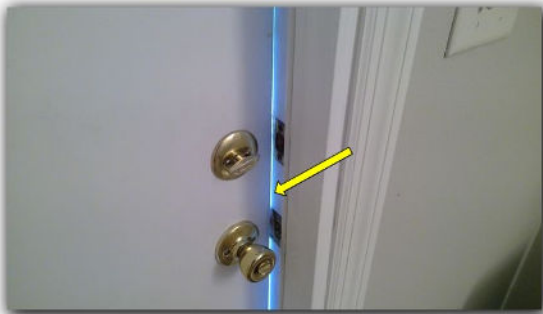
Rear guest bathroom door to rear porch rubs on jamb. Requires repair.

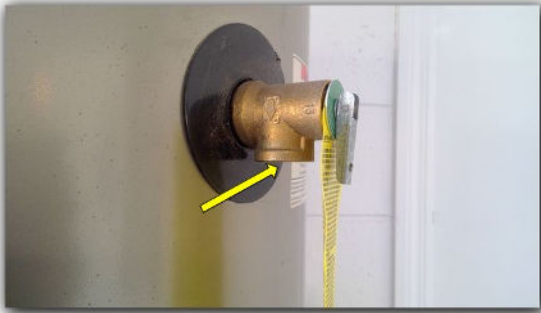
Pressure relief valve (PRV) is not plumbed to the floor or drip pan. A heat tolerate piping material is required to be installed from the prv to the floor or drip pan within 4 inches, to prevent damage or injury. Requires repair by a licensed plumber.

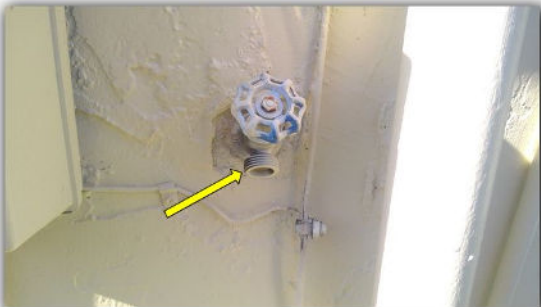
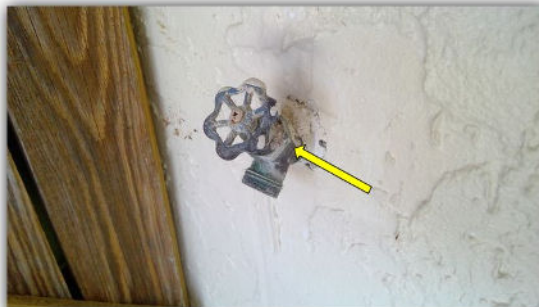
Note: It appears that several hose bibs at exterior have been abandoned. Possibly due to entire home re pipe. Recommend further evaluation by a licensed plumber.

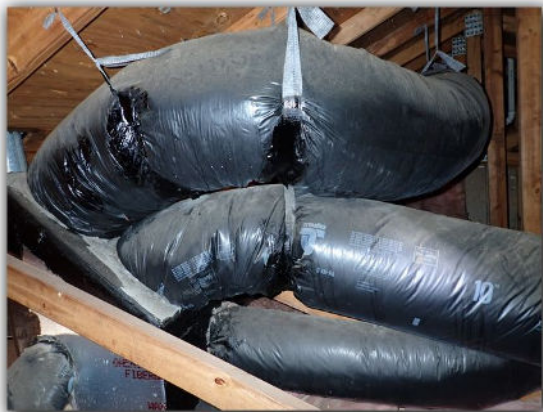
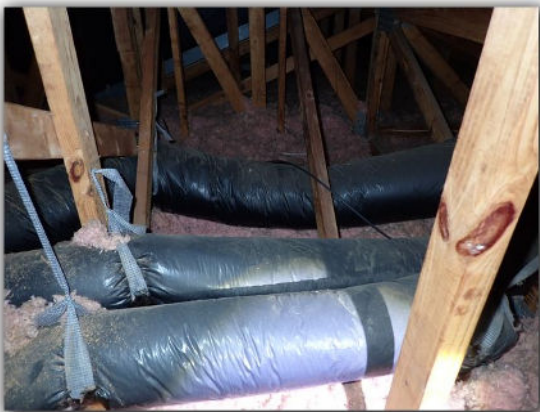
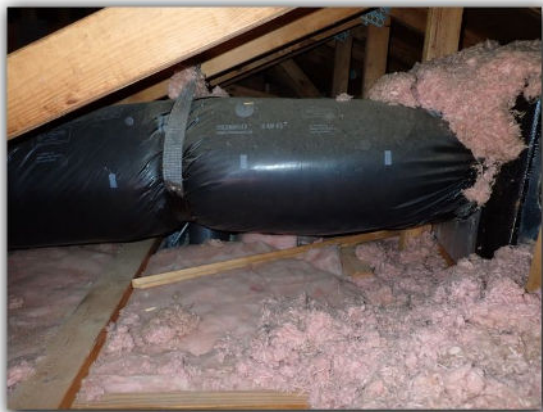
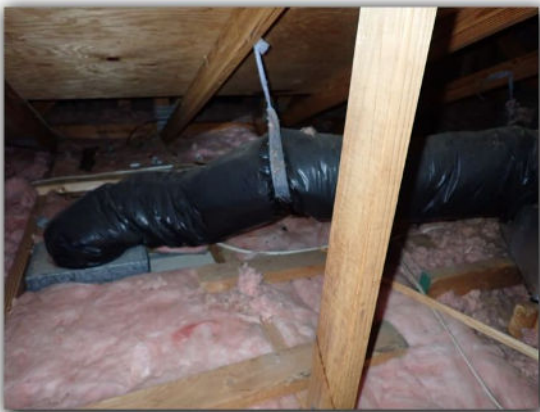
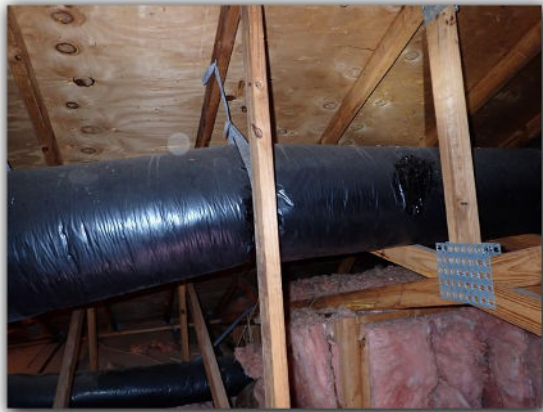
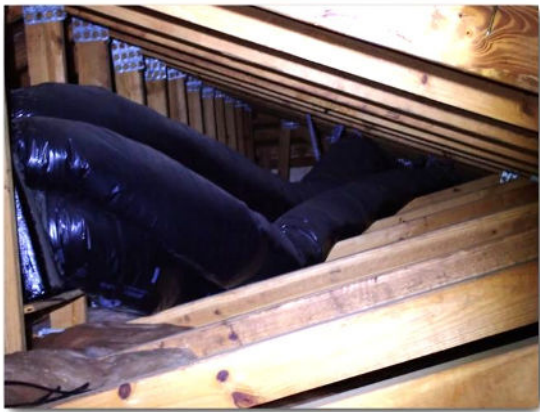
Hvac duct in attic, next to access in garage is in worn condition. Requires repair or replacement by a licensed hvac contractor.

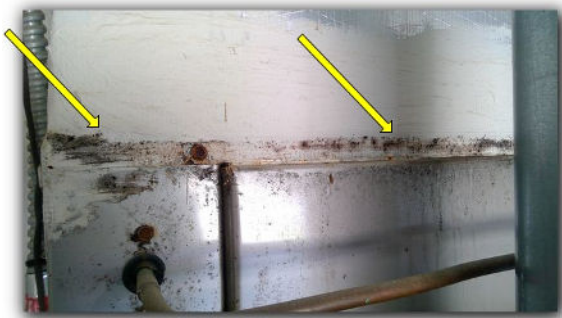
Air handler has possible mold growth on duct work. Recommend mold remediation in this area and resealing of ductwork.

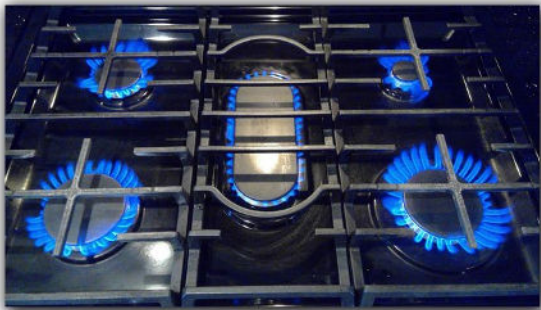
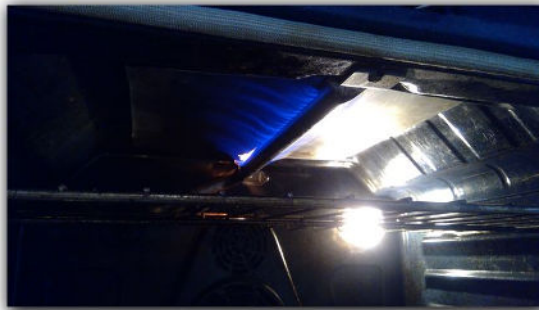
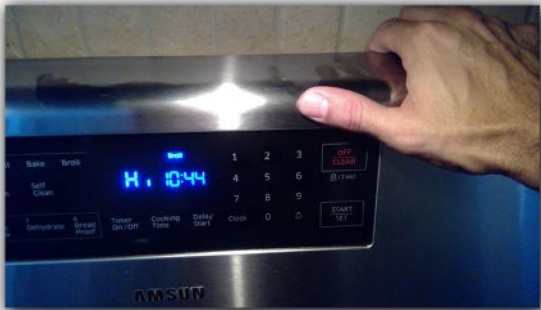
Stove anti tip brackets have been required by the appliance manufacturer association from June of 1991. There is no evidence of an anti tip bracket present at the stove. Recommend installation of bracket to prevent injury.

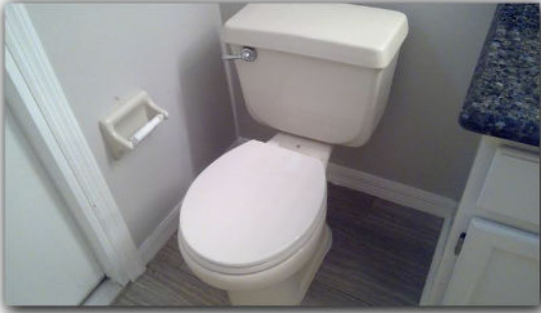
Water closet is loose at floor in guest bathroom. Requires repair.
